Re: Seaside Play Park, Playground at 12 Howe Street, Lockeport, Nova Scotia

On April 16, 2025, a visit was made to the Town of Lockeport community playground known as the "Seaside Play Park" located at 12 Howe Street. The purpose of the site visit was to examine the pieces of playground equipment located in this play area to determine if any deficiencies were found and to make appropriate recommendations if warranted. Equipment was examined and surveyed to determine if it met the requirements of CSA-Z614:20 "Children's playspaces and equipment". All equipment is located within a 1.7m (65") chain link fenced area that has a set of entrance gates that are kept locked when required.

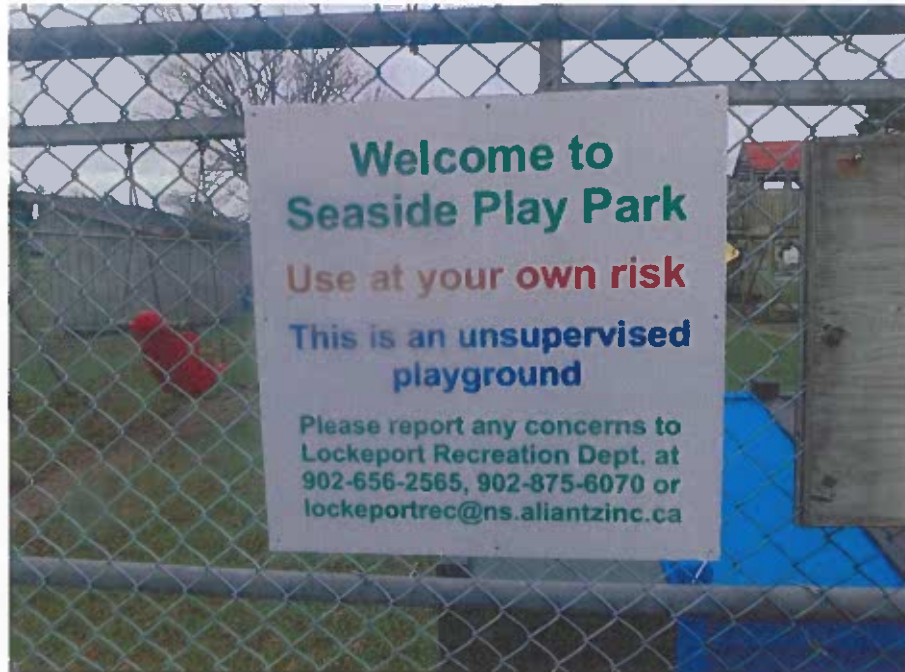
- (c) An owner/operator sign has been provided at the main entrance gate that states who is the owner of the equipment and their phone number to contact. A manufacturer's sign/sticker has been not provided for general playground area and equipment stating the age group the equipment is approved for use (rec. made).

**Owner/Operator Sign**

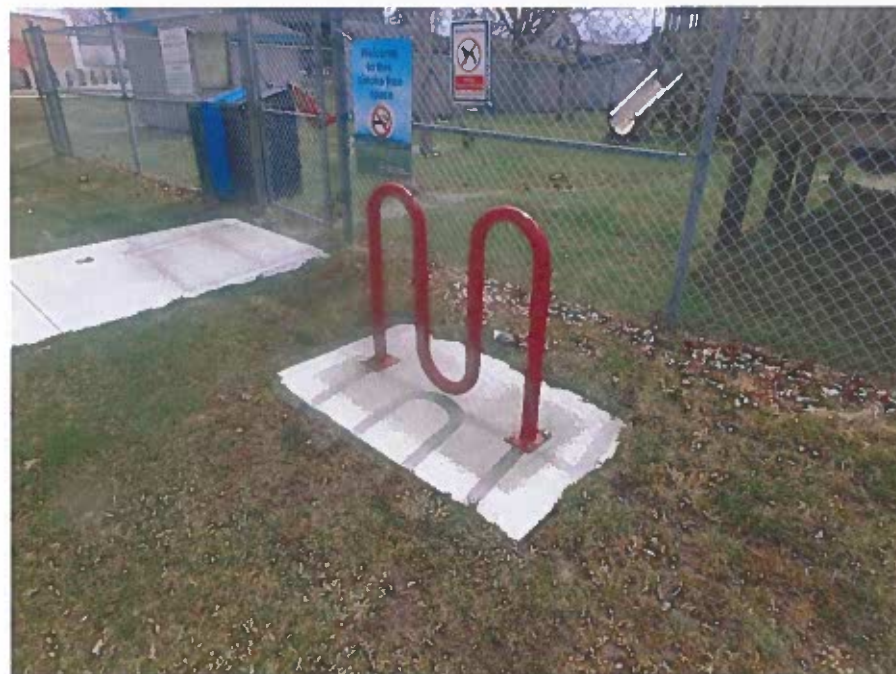
- (d) Located on a concrete pad at main entrance gate is a painted metal bicycle rack.
- (e) Due to the estimated age of this equipment and the numerous deficiencies found within including the absence of a large protective surfacing material area along with non-encroachment zones and swings sets attached to composite play structures, it may be fiscally imprudent to conduct the necessary repairs on existing structures.

**Bicycle Rack at Entrance Gate Area**

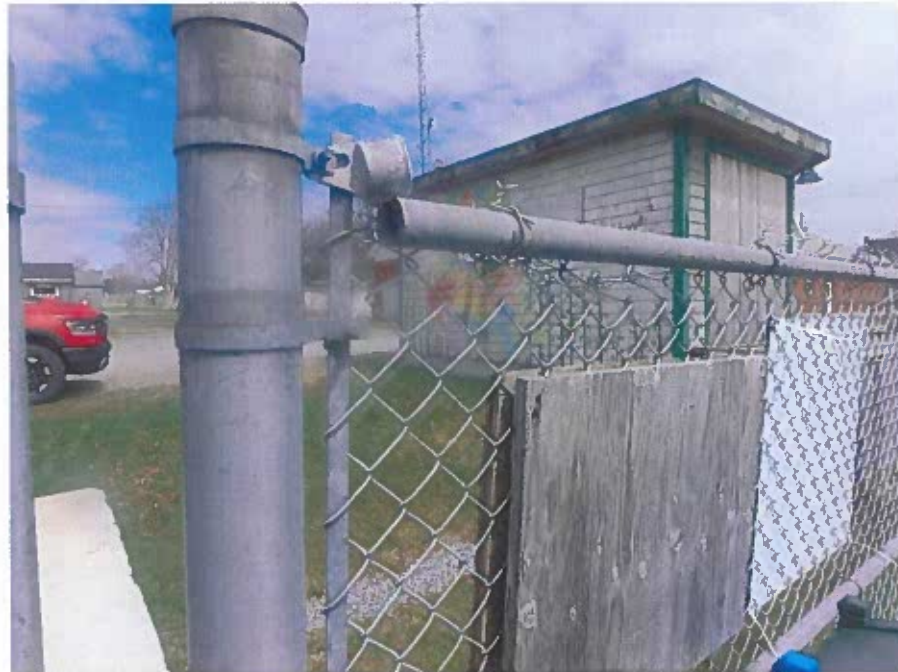
**Disconnected Frame Pieces**

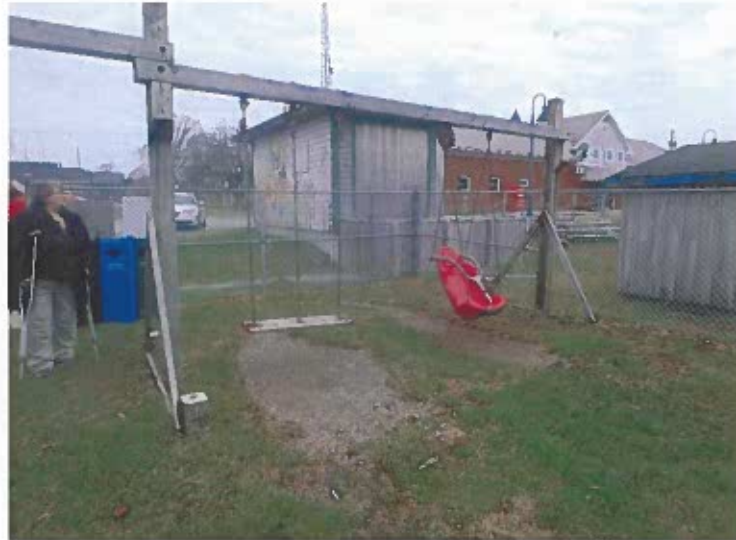
- (a) The swing set is attached to a functionally linked play structure (rec. made).

**Swing Set Attached to Play Structure**

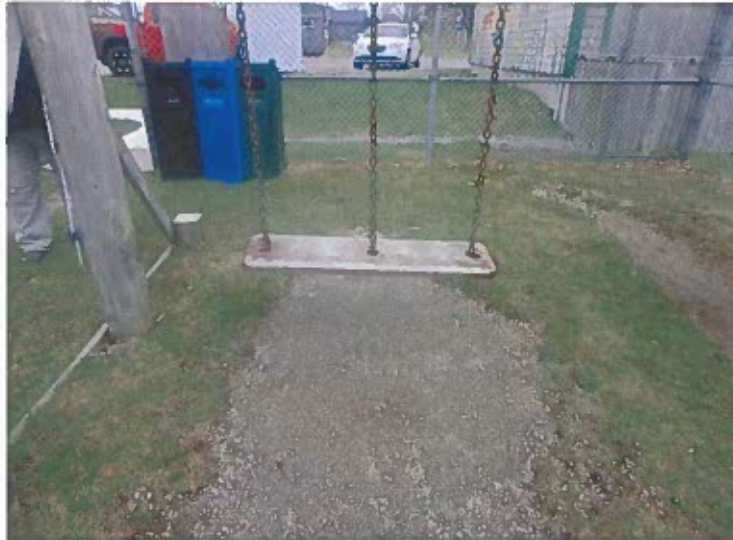
(b) A double person swing seat constructed of wood is located on the swing set (rec. made).

**Double Person Wood Swing Seat**

- 2025-05 To bring the "medium sized" play structure up to standard, the following items should be addressed:
- (a) The double wood swing seat should be replaced with a standard rubber swing set.

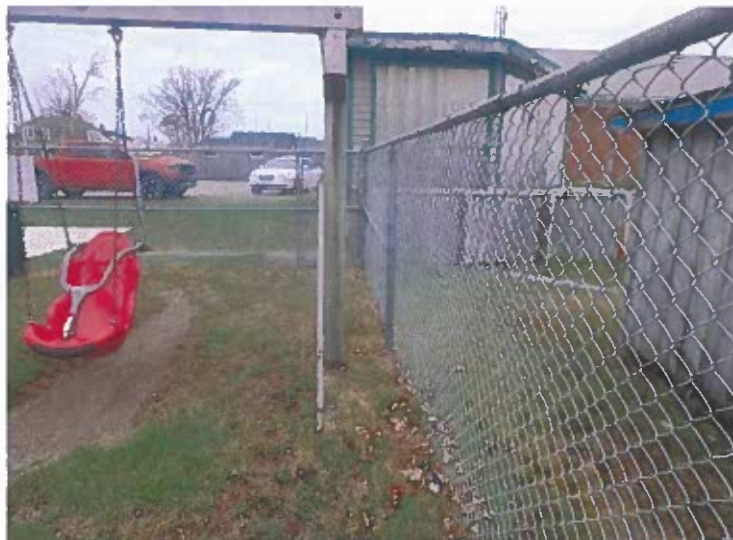
(c) Only 0.3m (1ft) of clearance has been provided from the right side of swing set (rec. made).

**Non-Standard Clearance to the Side of Swing Set**

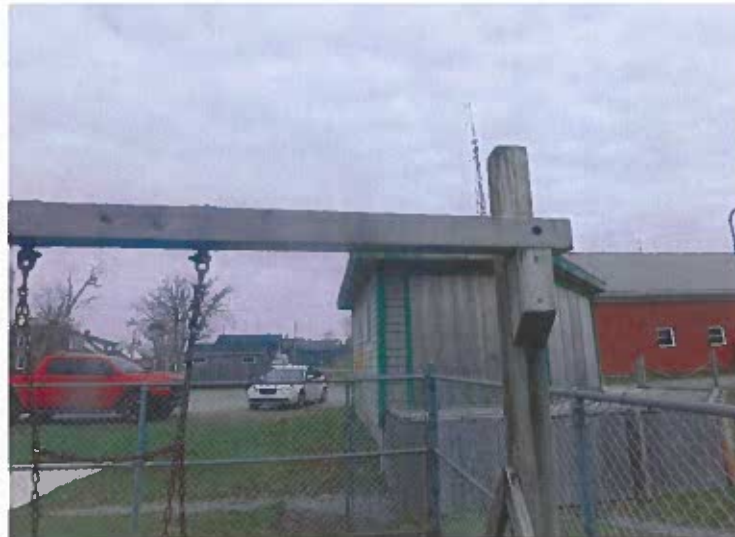
(d) The swing set cross beam is considered a designated play surface (rec. made).

**Swing Set Overhead Cross Beam**

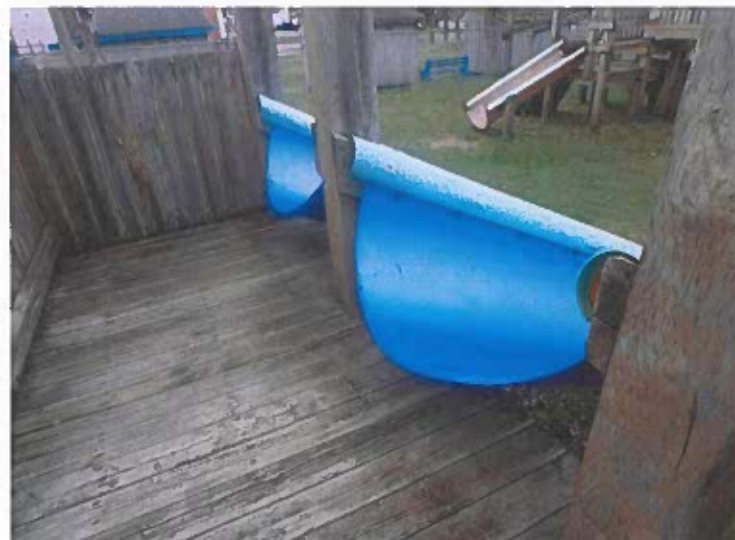
(e) A starting platform has not been provided for the half tube slides (rec. made).

**No Starting Platform for the Half Tube Slides**

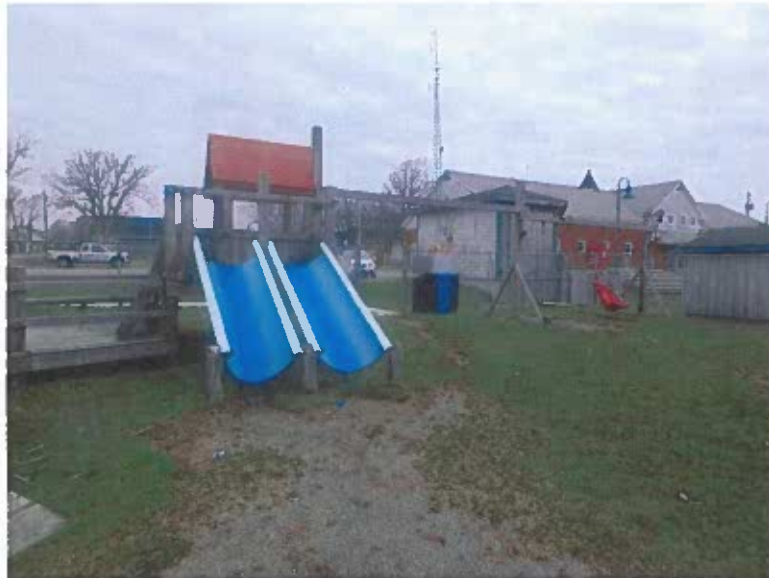
(f) A high sloped exit area is located for the half tube slides (rec. made).

**High Sloped Exit Area**

- (b) The exit area of each tube slide should be modified to provide an exit section having a slope between 0deg and -10deg from the horizon. Since the construction of the slide bed cannot be changed, all of the style of these slide beds located on the property should be replaced to a slide bed meeting the requirements of CSA Z614:20.

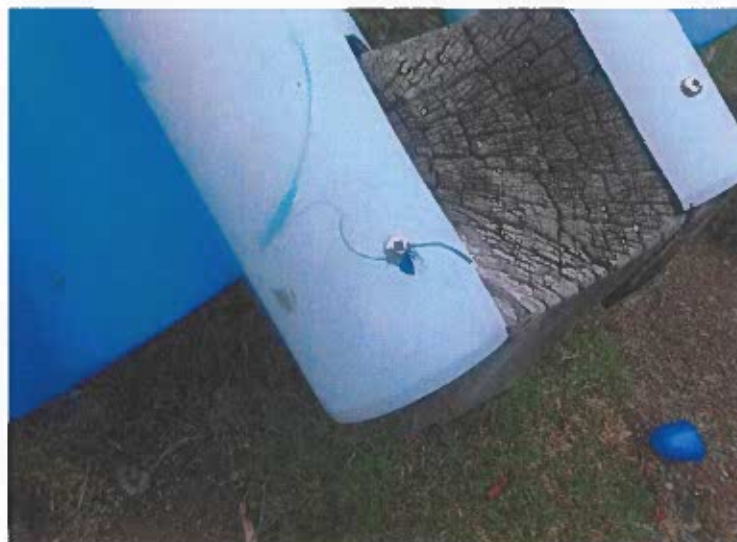
(g) The left side slide bed is cracked at the bottom (rec. made).

**Cracked Slide Bed at Bottom Frame Connection**

- (b) The cracked section of the half tube slide at the bottom of the slide bed should be repaired by a qualified individual.
  - (c) All rotted 8x8 wood columns should be replaced by a qualified individual.

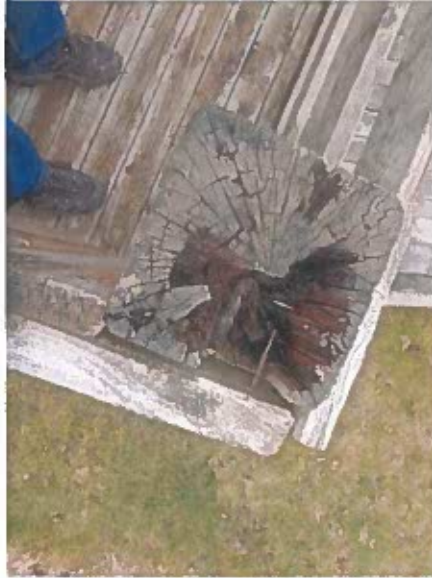
(h) Several 8x8 wood columns on the play structure were noted to be rotted (rec. made).

**Rotted Wood Columns on Structure**

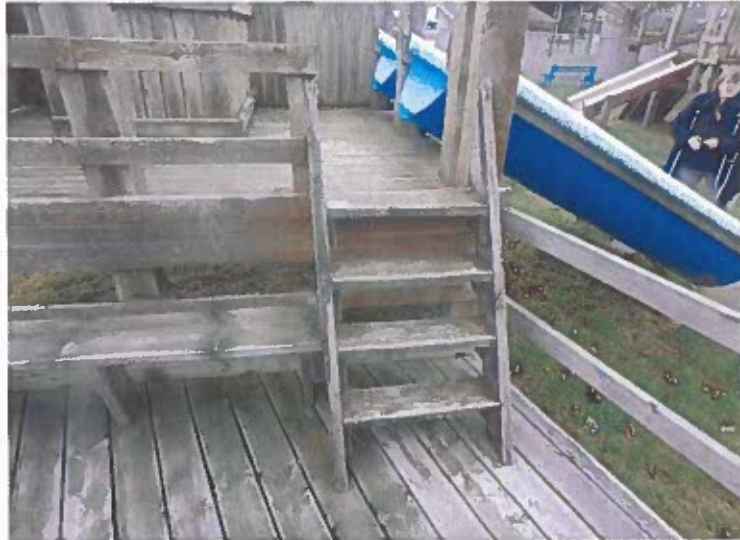
- (i) The set of stairs on the play structure are not provided with handrails. These stairs are also loose (rec. made).

**No Handrail on the Set of Stairs**

- (d) A handrail should be provided on each side of the set of stairs.
  - (e) The loose stairs should be repaired.
  - (f) All dangling swing chain noted at wood swing seat area should be removed.

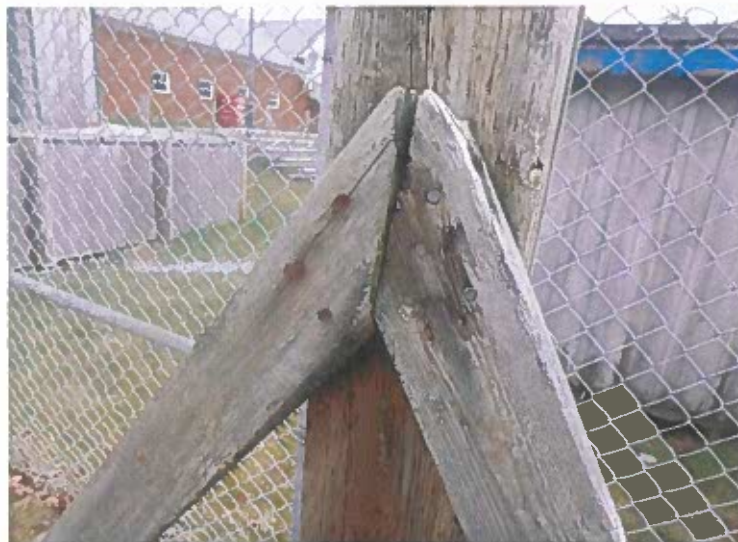
- (j) Nails used to connect building components (rec. made).

**Nails Used to Connect Wood Components**

- 2025-04 To bring each wood structure up to standard, all nails used as a fastener between structural elements should be replaced with nuts and bolts. Nails are only permitted to be used for wood decking.

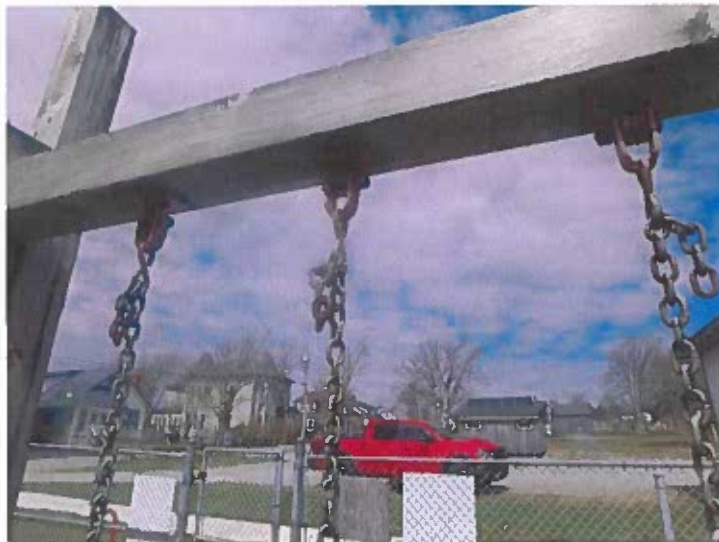
(l) Dangling swing chains were noted with wood swing seat (rec. made).

**Dangling Swing Chains**

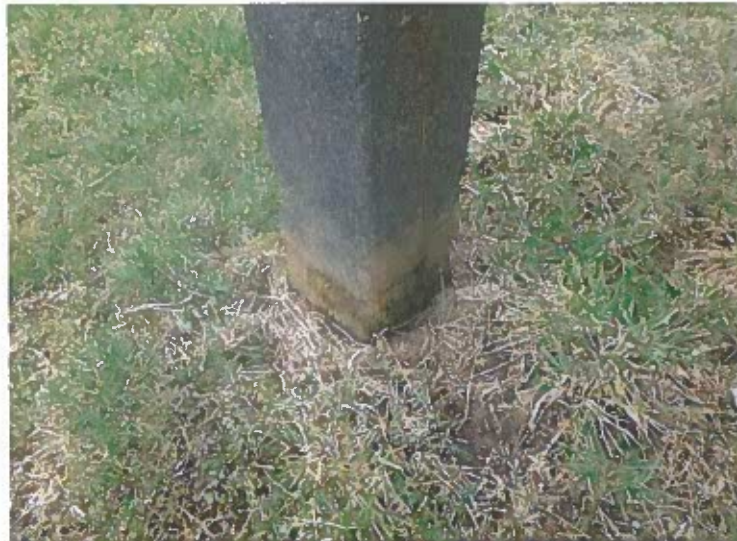
- (a) Several wood columns are rotted on the play structure (rec. made).

**Rotted Wood Columns**

- 2025-09 To bring the "large" creative play structure up to standard, the following items should be addressed:
- (a) All rotted 8x8 wood columns on the structure should be replaced.

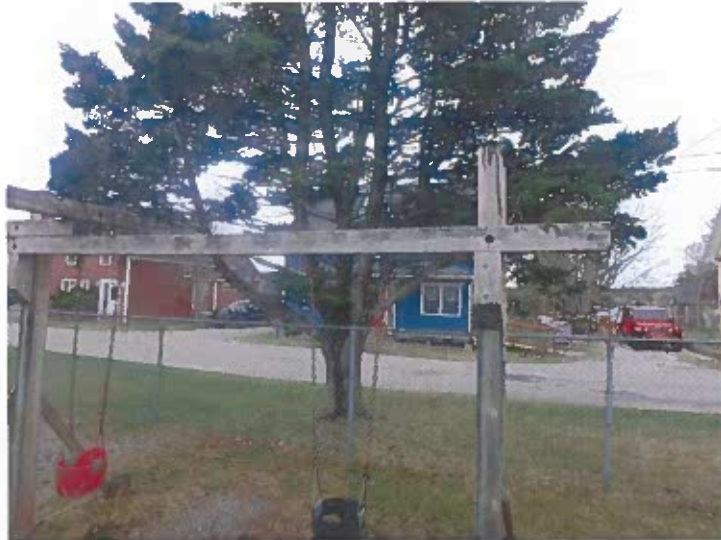
(b) A designated play surface is located on several areas of the structure due to 6x6 wood members (rec. made).

**Designated Play Surface on Structure**

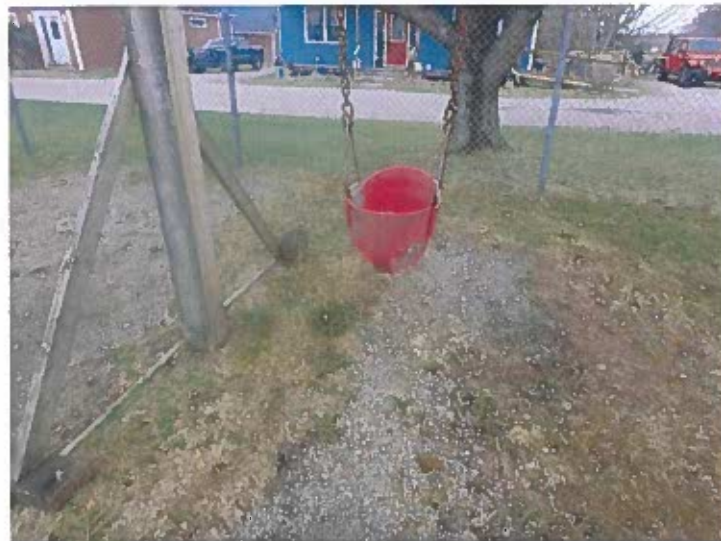
(c) There is no protective surfacing material beneath the equipment (rec. made).

**No Protective Surfacing Material**

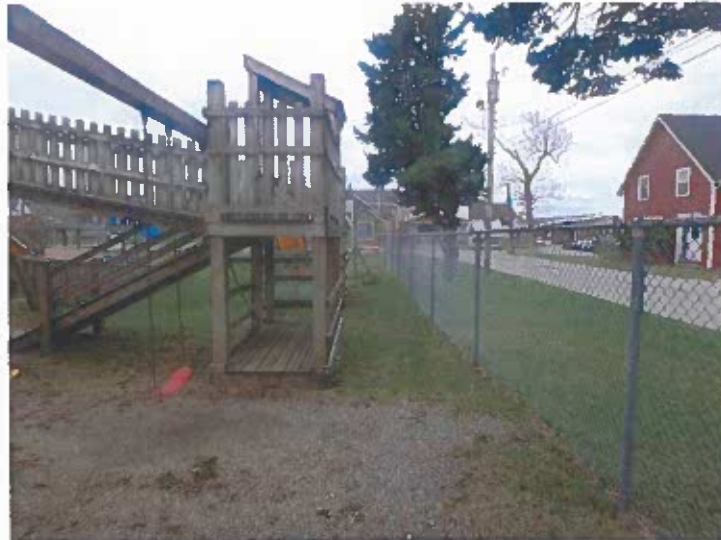
(d) Non-standard protective surfacing zone to the rear of the structure (rec. made).

**Non-Standard Protective Surfacing Zone**

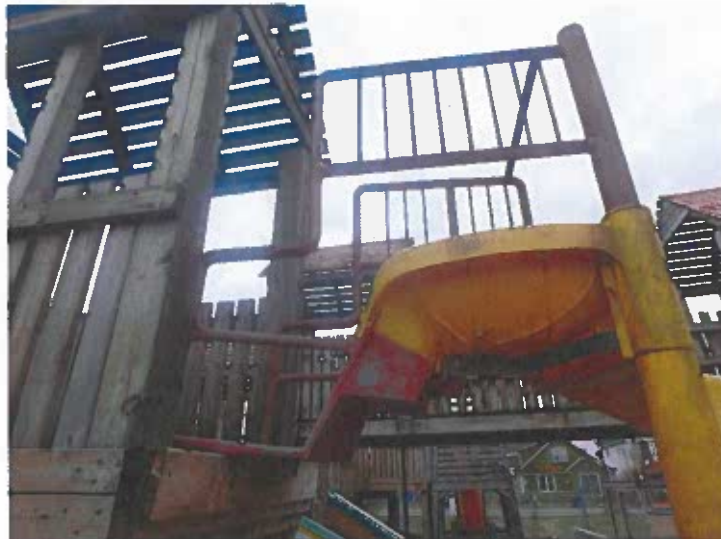
(e) Non-standard openings at guardrails were noted at the top of the spiral slide (rec. made).

**Non-Standard Openings on Guardrails at Top of Spiral Slide**

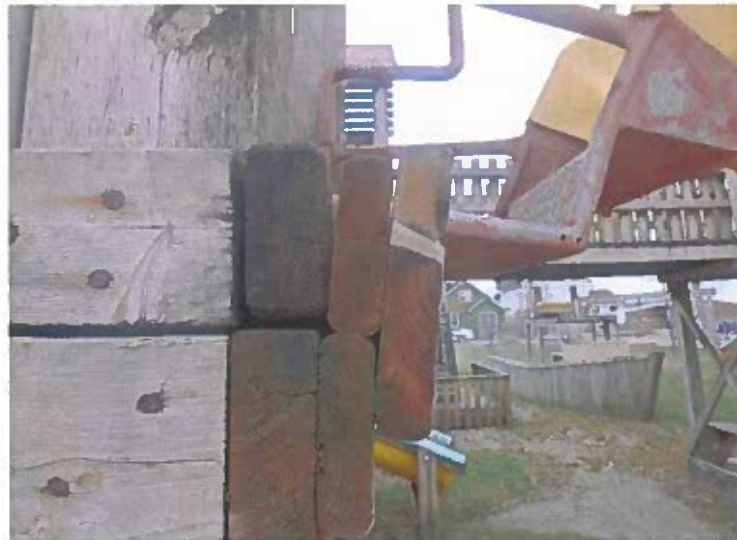
(f) Spiral slide wood connection member is beginning to detach from the structure at spiral slide area (rec. made).

**Wood Member Beginning to Detach at Spiral Slide Area**

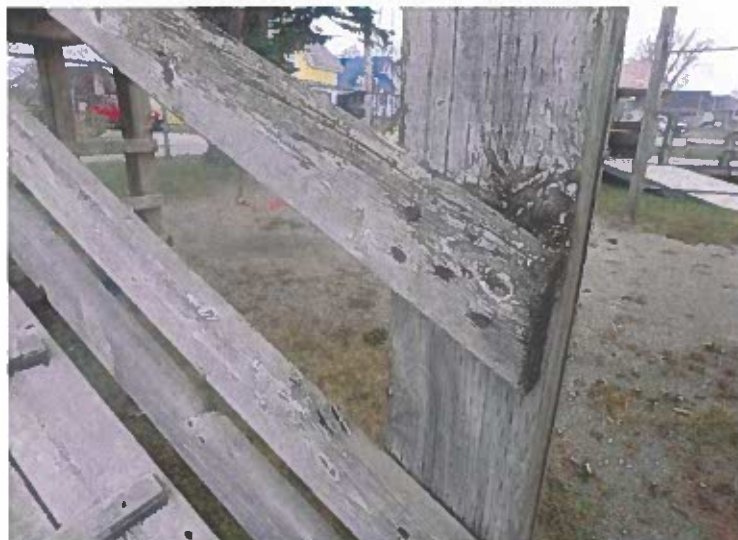
(g) Nails used to fasten wood components together (rec. made).

**Nails Used to Fasten Wood Components**

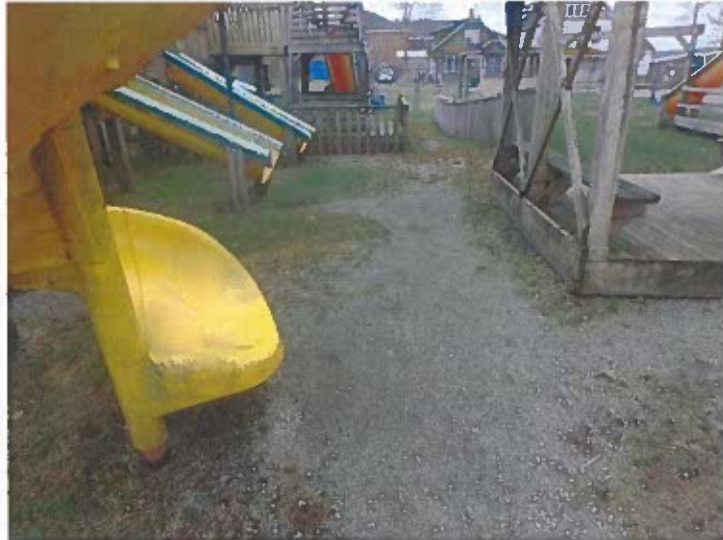
(h) A non-standard clearance of only 2.01m (79") is provided to the front of the spiral slide (rec. made).

**Non-Standard Clearance to Structure at Front of the Spiral Slide**

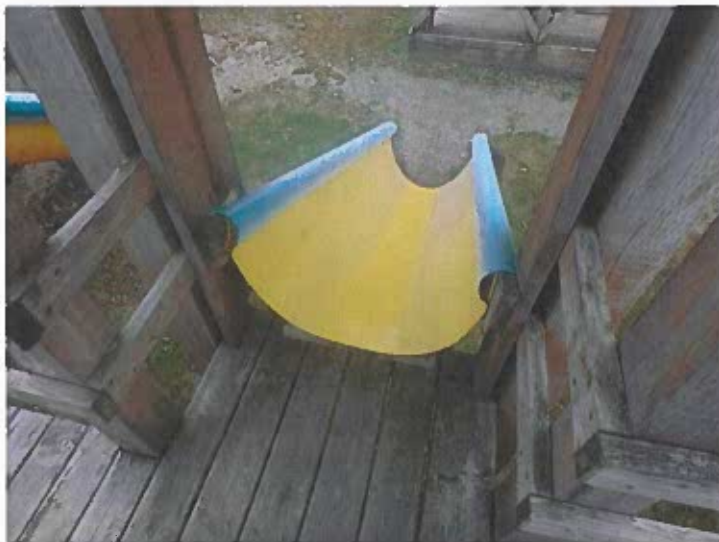
(i) A non-standard platform has been provided for each half tube slide (rec. made).

**Non-Standard Platform for Half Tube Slide**

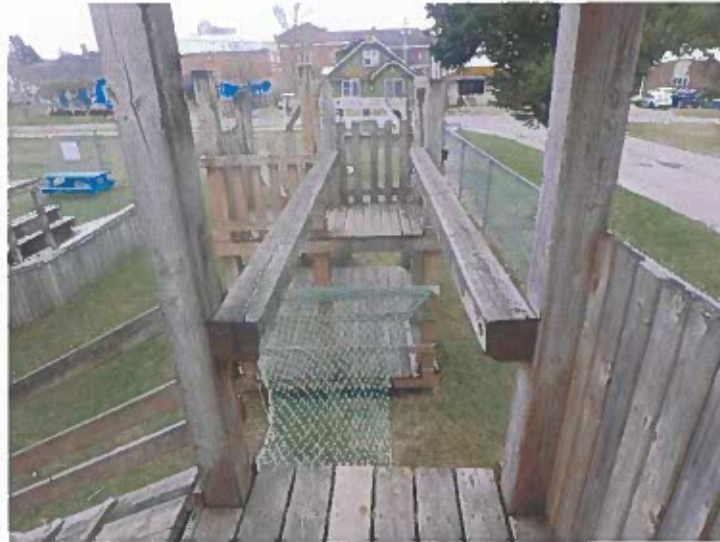
(j) A guardrail opening was noted above hammock netting (rec. made).

**Open Guardrail Above Hammock Netting**

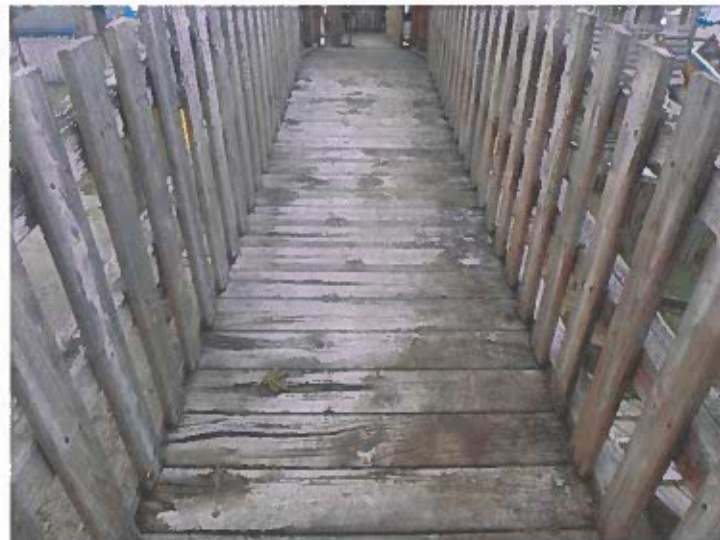
(k) Some rotted platform deck boards are located on the structure (rec. made).

**Some Rotted Deck Boards on Structure**

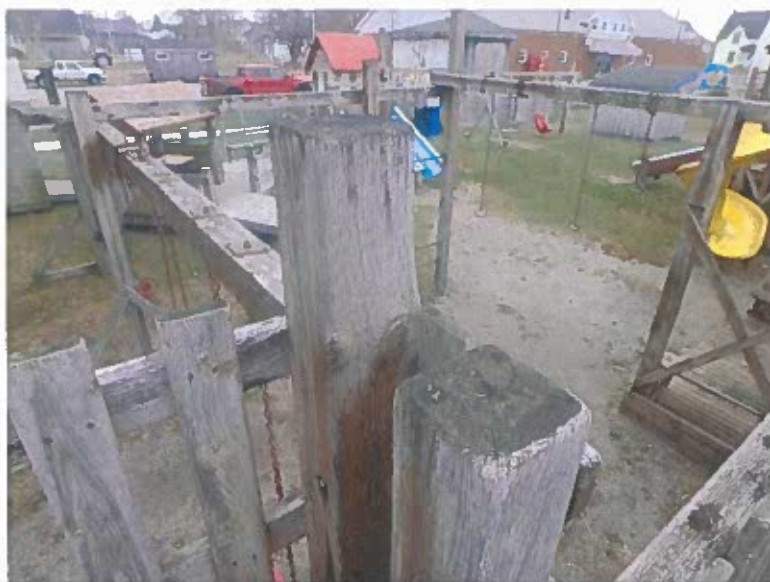
(l) No column post caps are located on 6x6 upright members (rec. made).

**No Post Caps**

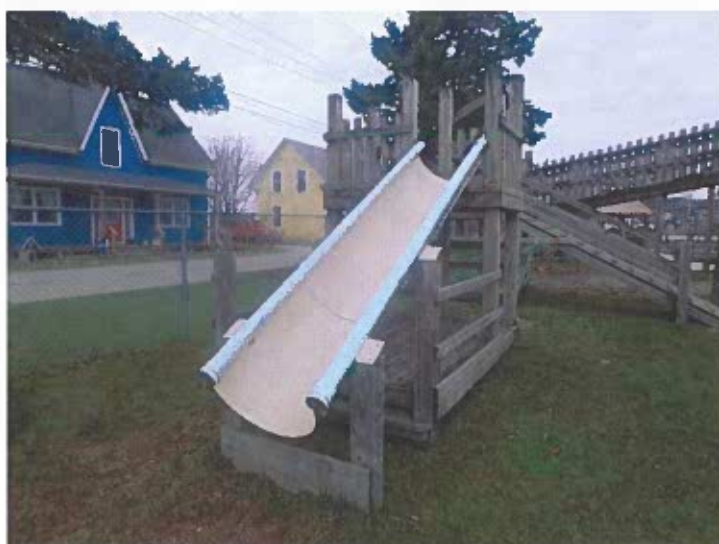
(m) Non-standard exit height of half tube slide (rec. made).

**Non-standard Exit Area on Half Tube Slide**

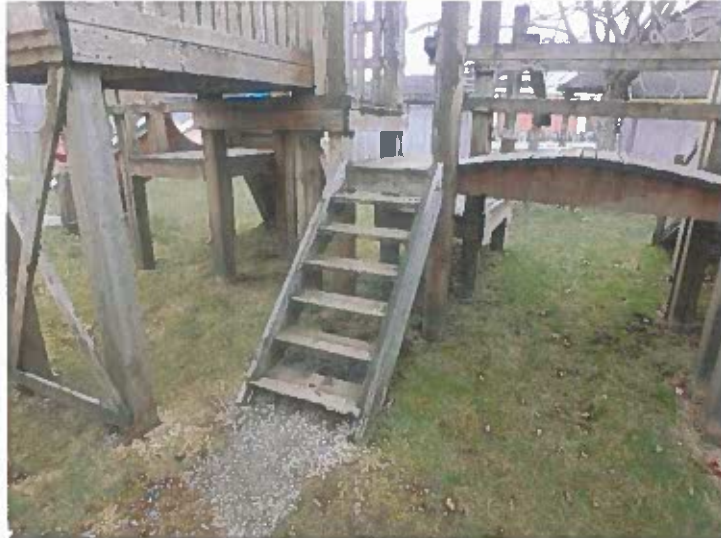
(n) There is a set of stairs on the structure with no handrails (rec. made).

**No Handrails on the Set of Stairs**

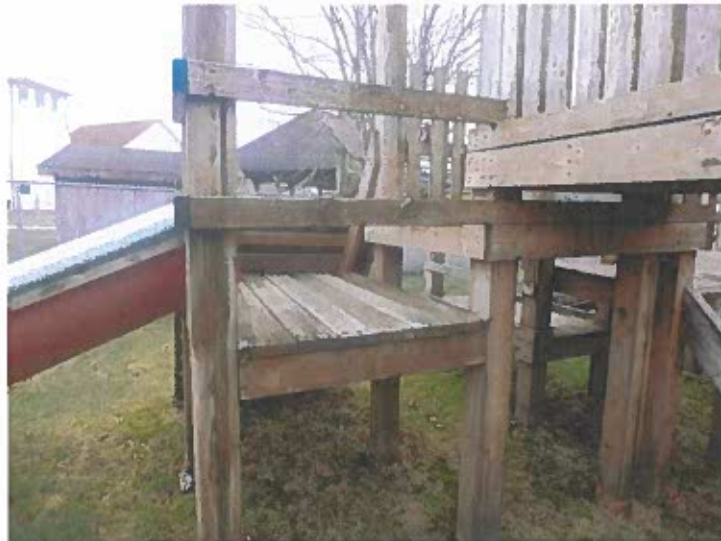
(o) Non-standard guardrails on platform (rec. made).

**Non-Standard Platform for Half Tube Slide**

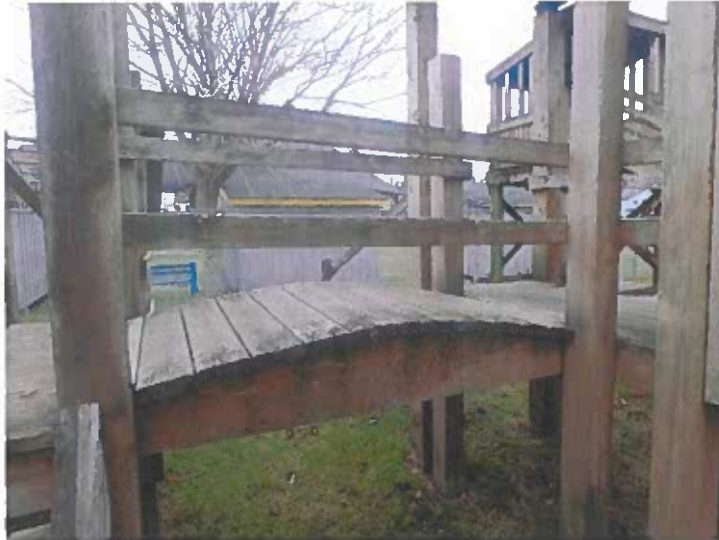
(p) Non-standard guardrails on bridge (rec. made).

**Non-Standard Bridge Guardrails**

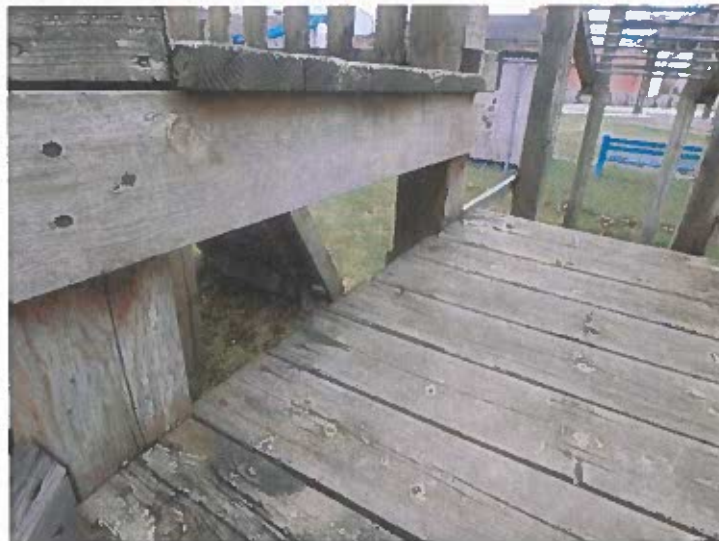
(q) Torso entrapment between platforms (rec. made).

**Torso Entrapment Between Platforms**

- 2025-08 To reduce the potential of a head and neck and a torso entrapment hazard, a review of all openings between wood components in both the horizontal and vertical planes on each play structure located on the property should be documented. Any opening ranging from 89mm to 227mm (3.5" to 9") (openings are actually considered with the use of a head and neck or torso probe but these measurements can be used for generalization) should be properly in-filled to remove the hazard. Several of these non-standard openings were noted between guardrail railings, intermediate panels, ramp railings, etc. were noted in various areas on the property that would take a concerted effort to rectify.

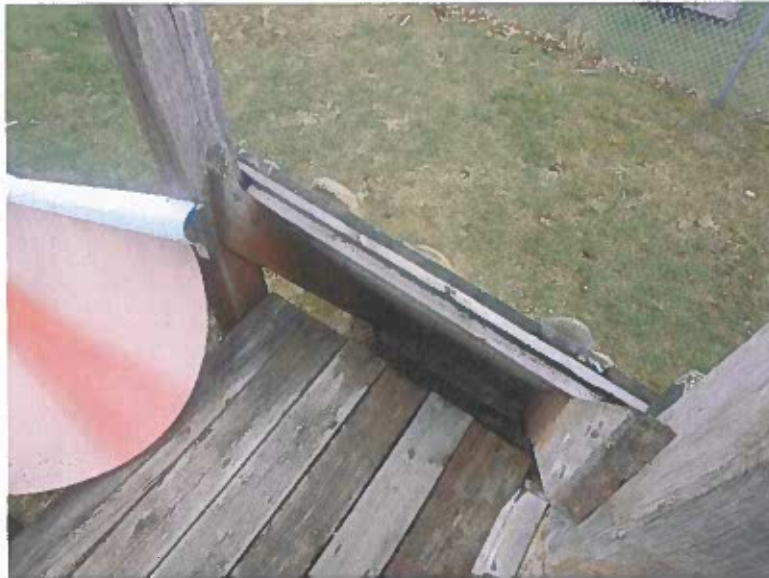
- (r) Top of rock-climbing ramp is not flush with adjacent platform surface (rec. made).

**Rock Climbing Ramp Not Flush with Platform Surface**

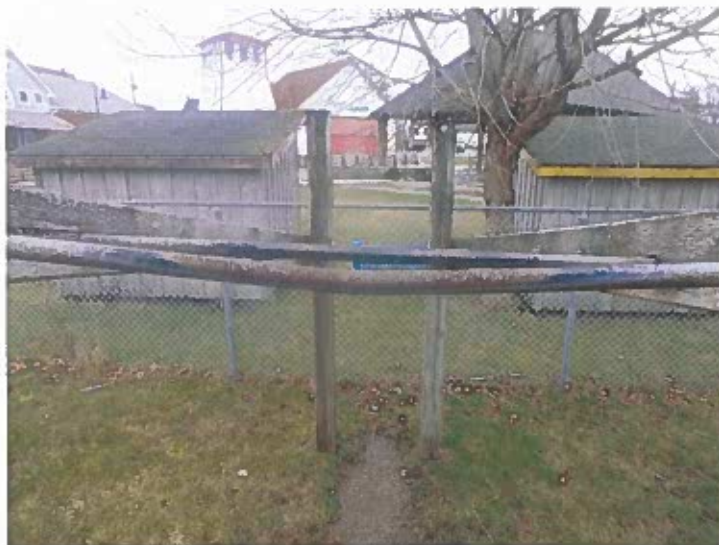
- (s) One bar on overhead climber is bent (rec. made).

**Bent Bar on Overhead Climber**

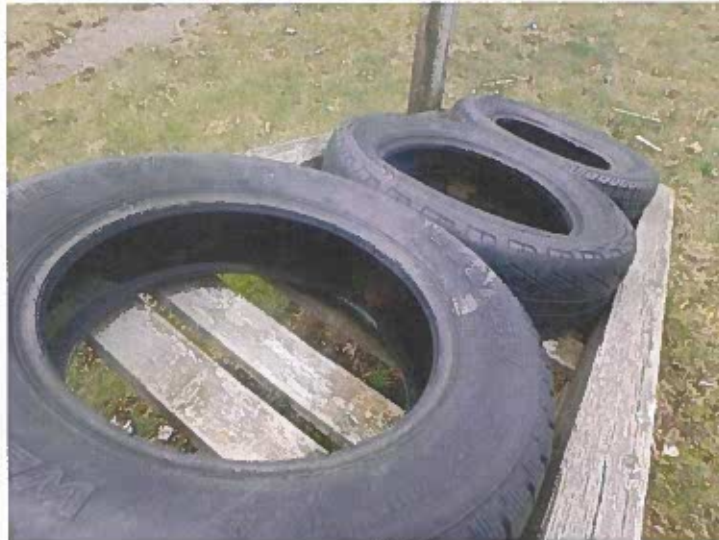
(t) No drain holes in tires on tire climbing ramp on-standard guardrails on bridge (rec. made).

**No Drain Holes in Rubber Tires**

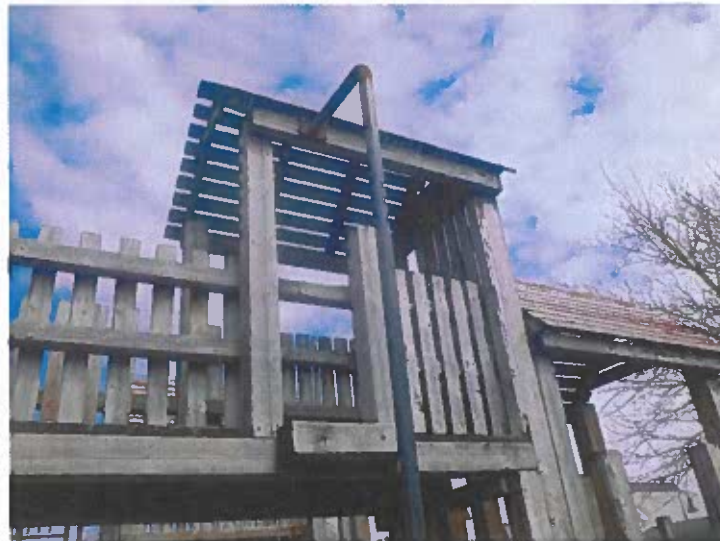
(u) The diameter of slide pole is 63mm (2.5") (rec. made).

**Non-Standard Slide Pole Diameter**

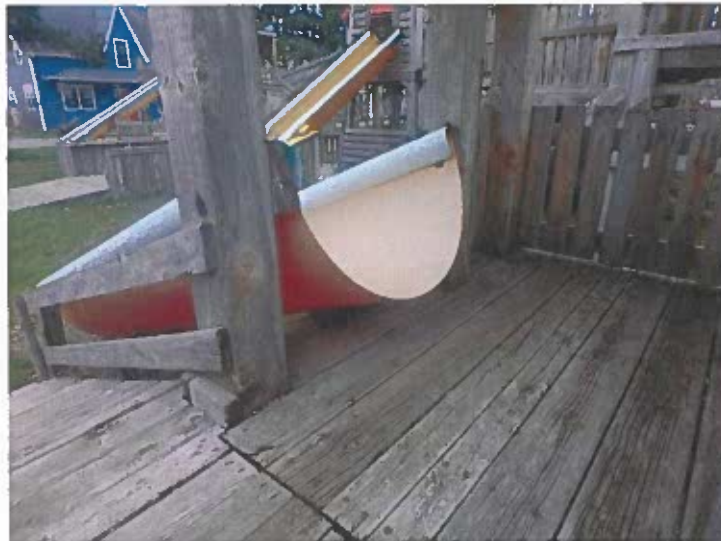
- (a) No starting platform on half tube slide (rec. made).

**No Starting Platform for Half Tube Slide**

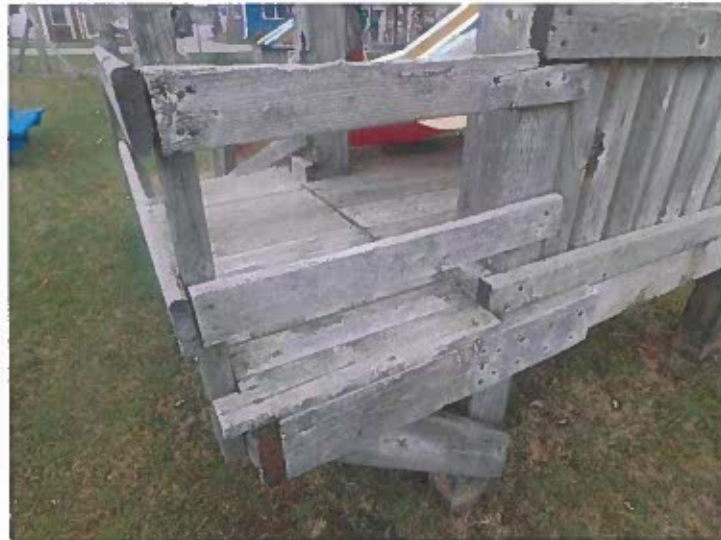
(b) A torso entrapment hazard is located on the platform of the structure (rec. made).

**Torso Entrapment Hazard**

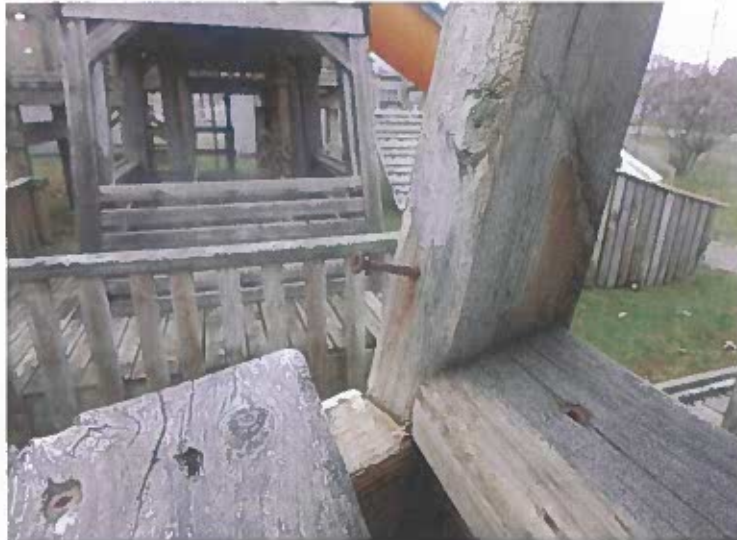
There are some protruding screws on the play structure (rec. made).

**Protruding Screw on Structure**
